Kidd Mine – dealing with the issues of deep and high stress mining – past, present and future

DB Counter *Glencore Canada Corp., Canada*

Abstract

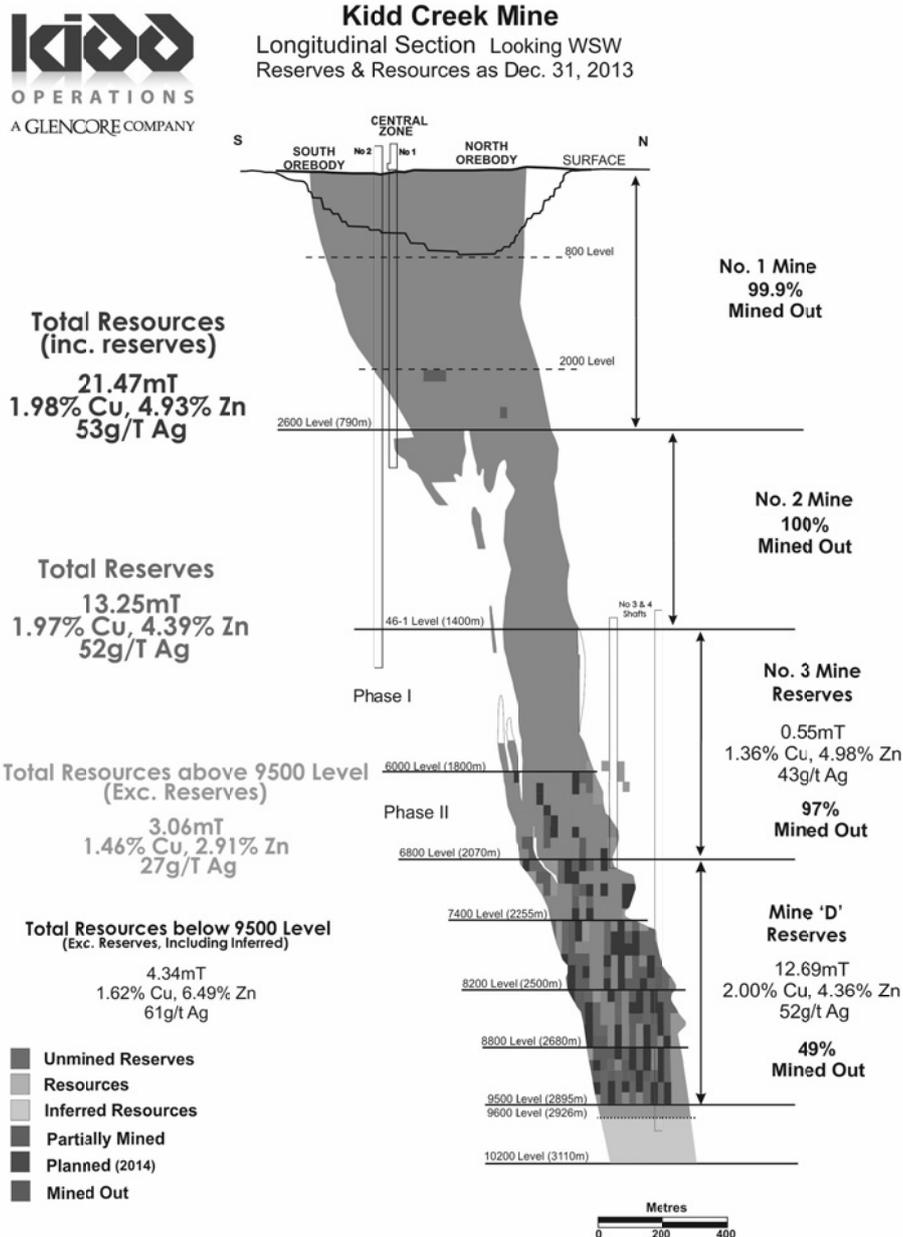
Figure 1 Kidd Creek long section, showing extent of historical mining and reserves

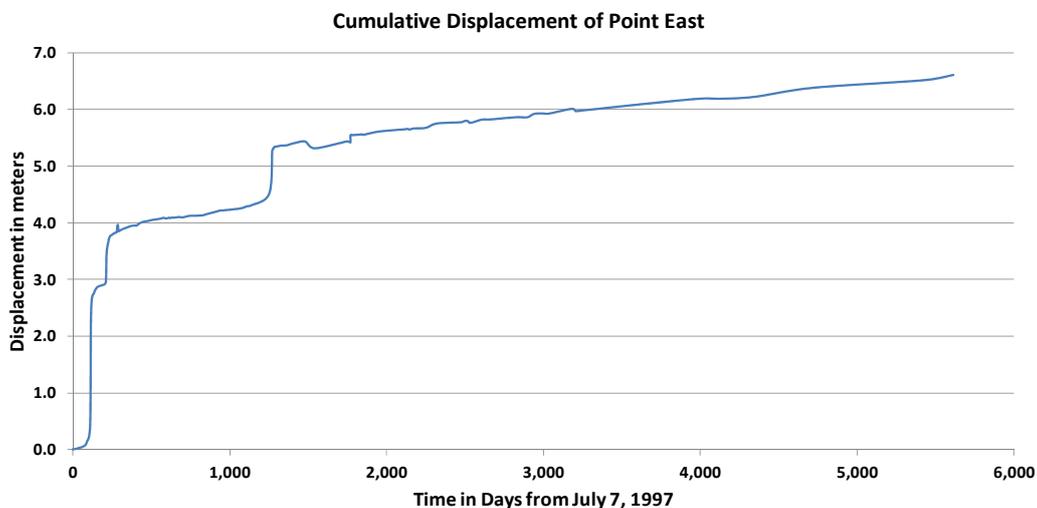
Figure 2 Displacement trace of survey monument Point East, since onset of accelerated hanging wall failure in July 1997. The Point East survey monument was lost during a local ground fall in June 2013

In the summer of 1997, after 88% of the reserves in No. 1 Mine had been recovered, a modest change in the rate of movement of the pit crest was observed, amounting to approximately 6 cm over the course of several months. Reading frequencies were increased, and coupled with observations of increasing deformation underground to depths approaching 600 m, it became apparent that an incipient large scale failure was occurring in the hanging wall of the pit, extending into the underground workings. The failure has been described previously (Board et al. 2000). The rock mass failure resulted in the loss of access to the hanging wall of the orebody over nine levels, the loss of five main fill distribution conveyor systems, most of the hanging wall sump and dirty water pumping systems, and two secondary exhaust raises above the 2000 Level. The site was proactively closed for four days during the event.

Through the use of manual (and ultimately automated) survey monitoring of the pit slopes, and three-dimensional distinct element modelling, the failure was analysed and found to be the result of a very steep sided wedge subsiding into the underground workings, essentially down dip of the plunge line of the intersecting structures. It was determined that similar failure was possible in other quadrants of the pit, based on the presence of major steeply dipping structure, which could negatively impact significant elements of the mine infrastructure, including the shafts, ramp, and ventilation raises. As a result, the mining strategy was changed within the No. 1 Mine to restrict both the size and number of openings active at any given time, to minimise load and deformation rate changes and maintain confinement of the last remaining central yielding pillar supporting the foot wall. High risk stopes identified through the model were deferred until very late in mine life to reduce the risk of failure. Since the failure of the hanging wall in the No. 1 Mine, a total of 7.8 m t of ore were recovered over a period of approximately 13 years, representing another 11% of the reserves, with no significant deformation of the foot wall or critical

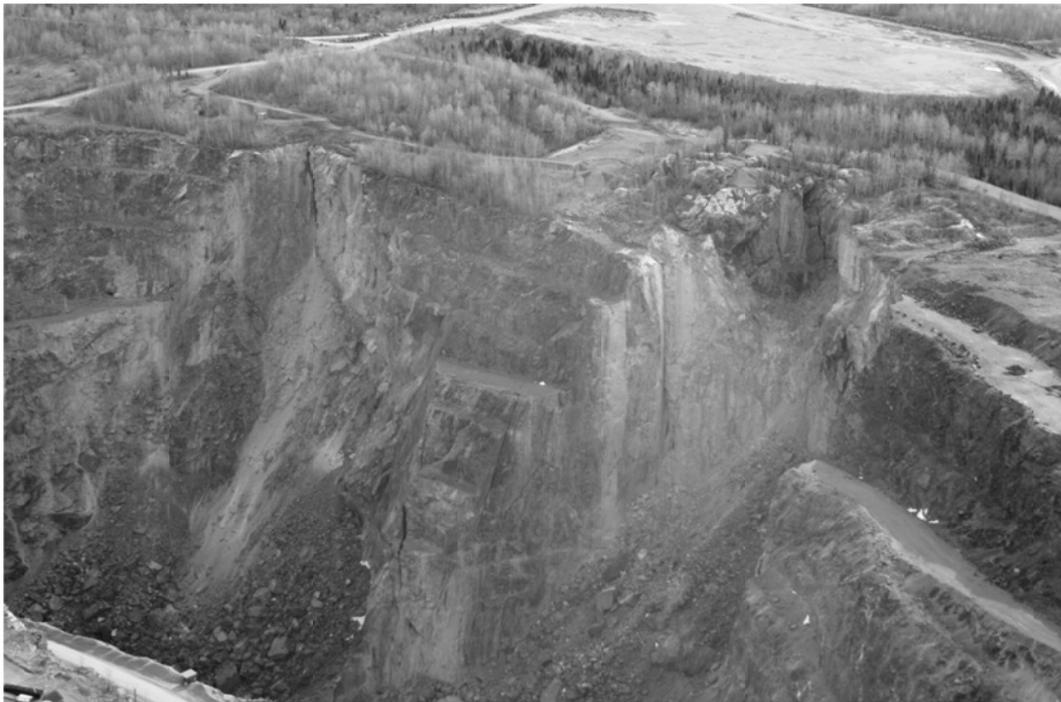
Figure 3 Hanging wall wedge 1997 failure zone, as photographed on 10 May 2013. Failure extends from embayment in pit wall at right, to near vertical structure in left background. Point East monitoring station on top of outcrop, in upper right near pit crest, failed due to undercutting in June 2013. Note tensile splitting of nose of wedge due to high imposed stresses caused by displacement towards the foot wall

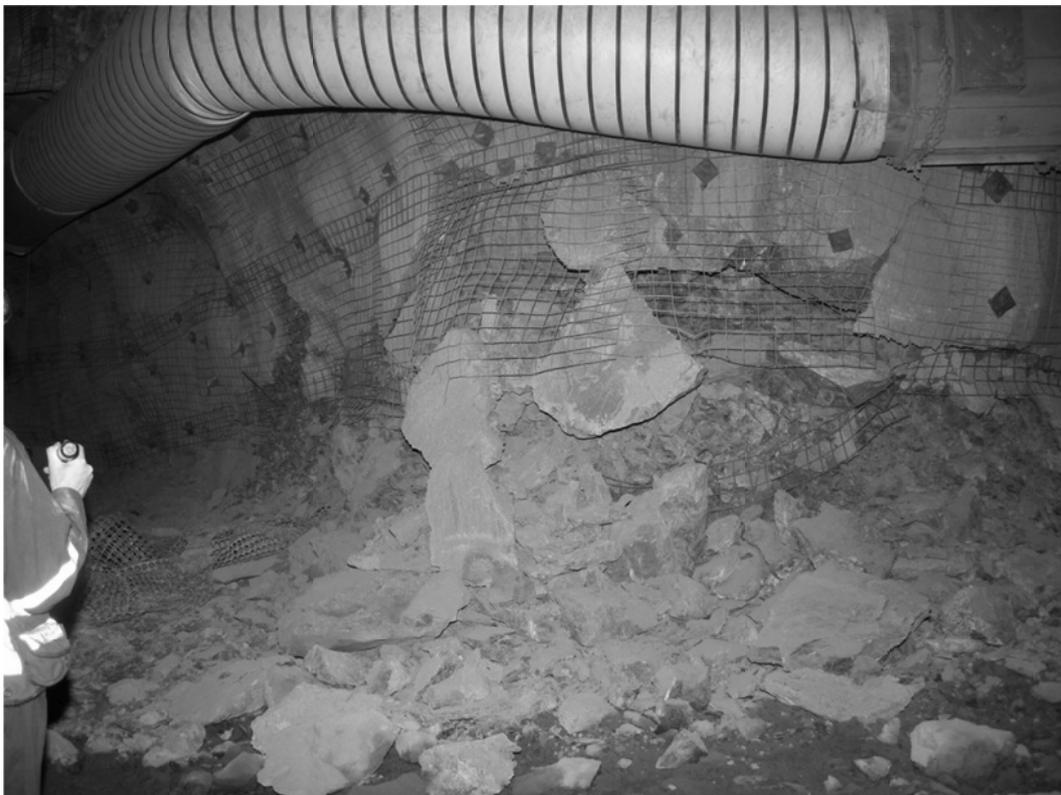
Figure 4 Damage at entrance to 70-82 XC from 6 January 2009 M_N 3.8 event. Note damage concentrated near unsupported floor. Dynamic support installed through straps

On 6 January 2009, a M_N 3.8 burst occurred on or about the 7000 Level near the southernmost limit of mining in the main ore zone, causing significant damage to multiple levels of the upper portion of Mine D, and lower 3 Mine. Damage was most significant in intersections which were not heavily reinforced at the time of capital development. Areas where dynamic rated support had already been installed fared much better. The event occurred along an incipient shear surface following a poorly defined joint set, linking the main ore zone mining to the satellite lens in the foot wall. Several subordinate surfaces, with the same strike and dip as the main rupture plane, also showed signs of movement. The structures were spaced roughly 20 m apart on centre, and dipped 65° to the west-northwest. The frequency and attitude of the structures was such that they intersected the next crosscut to the north on the level 40 m below (crosscuts also spaced 20 m apart), increasing the number of free surfaces into which the moving blocks could displace. Since the structures were also slightly oblique to the long axis of the crosscuts, the amount of damage in the crosscuts was significantly higher than that in the foot wall development.

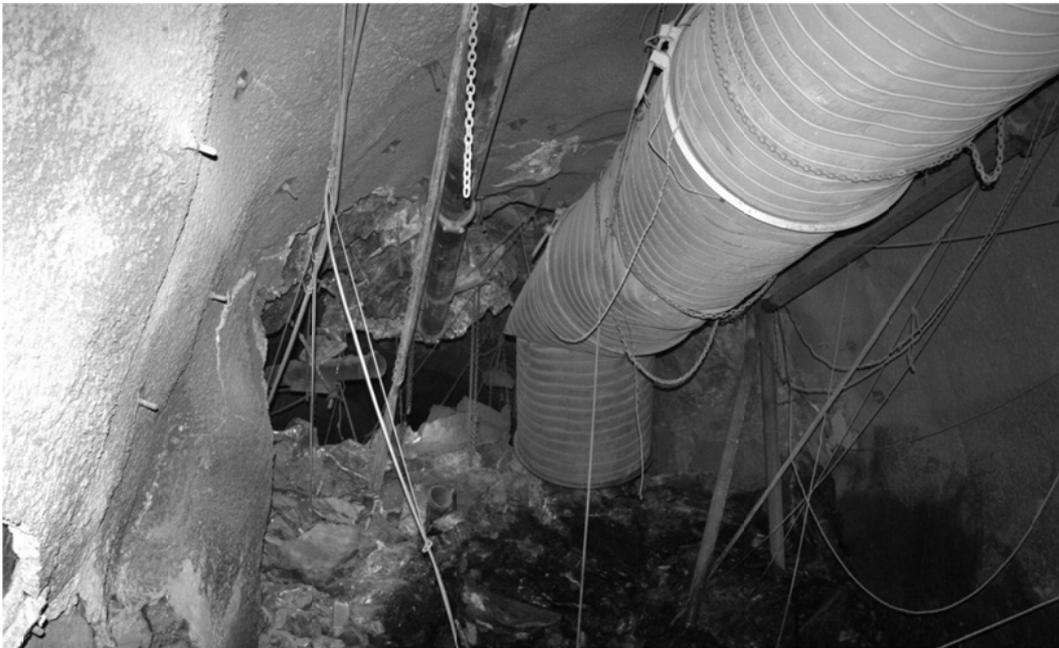
Figure 5 Damage to 71-01 Dr South at the intersection with 71-84 XC, 6 January 2009. Rupture plane cuts across back at end of truncated piping/vent duct. Original support comprised of 2.24 m rebar on 1.5 m square pattern over shotcrete, with widely spaced single strand 4.5 m long spin cables

Repairs took approximately 18 months to complete, and upon resumption of mining, another M_N 3.8 event occurred on 13 September 2011, in almost the same location as the event of 2009, on the same poorly developed incipient structure. Damage during the second event was significantly reduced as compared to the first large event, as the density and type of support were modified during the 2009-2010 repairs to better withstand future events of similar magnitude. The newer support included 2.24 m long friction stabilisers and both 2.24 and 3.7 m long high strain expandable bolts (in areas of highly broken ground where traditional resin based tendons could not be installed), together with closer bolting patterns resulting from additional 2.24 m by 22 mm rebar installed during the repair process, through 4.82 mm mesh, and closely spaced 2.24 m modified cone bolts through 7.77 mm straps in two directions. Where necessary, fibre reinforced shotcrete had been applied over heavily damaged areas prior to bolting and screening to return the development to nearly the original profile. All intersections were also reinforced with both 3.7 m long expandable friction bolts, and 10-15 m long twin plain strand plated cable bolts, also interlaced with 7.77 mm mesh straps in two directions, on 1.5 m spacing. Where the ground in the intersection roof was too damaged to allow cable bolts to be installed, self-drilling R32S soil anchors (continuously threaded hollow core rebar), were installed up to 9 m into the back, and were grouted in place using neat Portland cement grout. Straps were also installed between the soil anchors. All suspect surfaces were re-bolted, due to the unknown integrity of the original support.

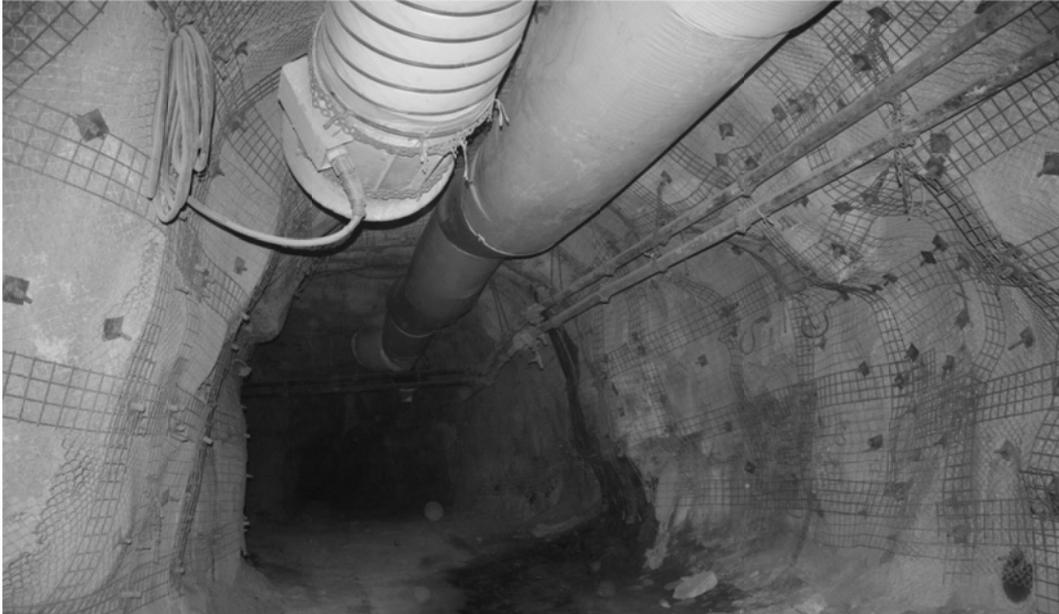
Figure 6 71-01 Dr South at 71-84 XC intersection, facing south, after repair. Rupture plane located at embayment on right. Temporary post out of field of view on left. Note use of 4.5 mm chain link fencing and 4.82 mm WWM over shotcrete, with various tendons

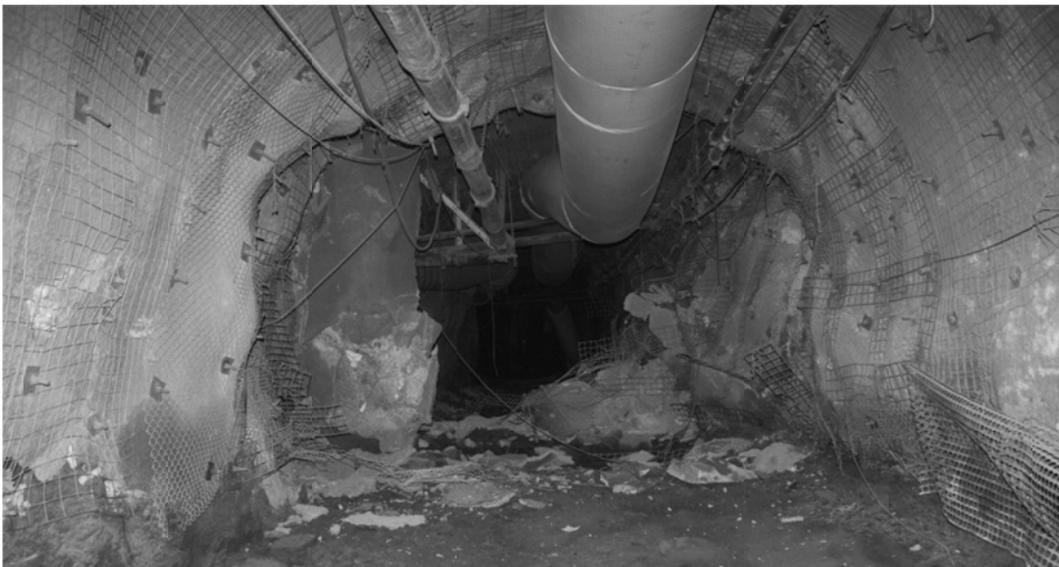
Figure 7 71-01 Dr South at the intersection with 71-84 XC, looking south, following second M_N 3.8 event of 13 September 2011. Note the damage to the stiff shotcrete post used to temporarily support the intersection back until permanent ground support tendons were installed. Note limited damage to western wall in the immediate vicinity of the rupture surface, at the embayment in Figure 6. Damage concentrated near floor, which is not supported

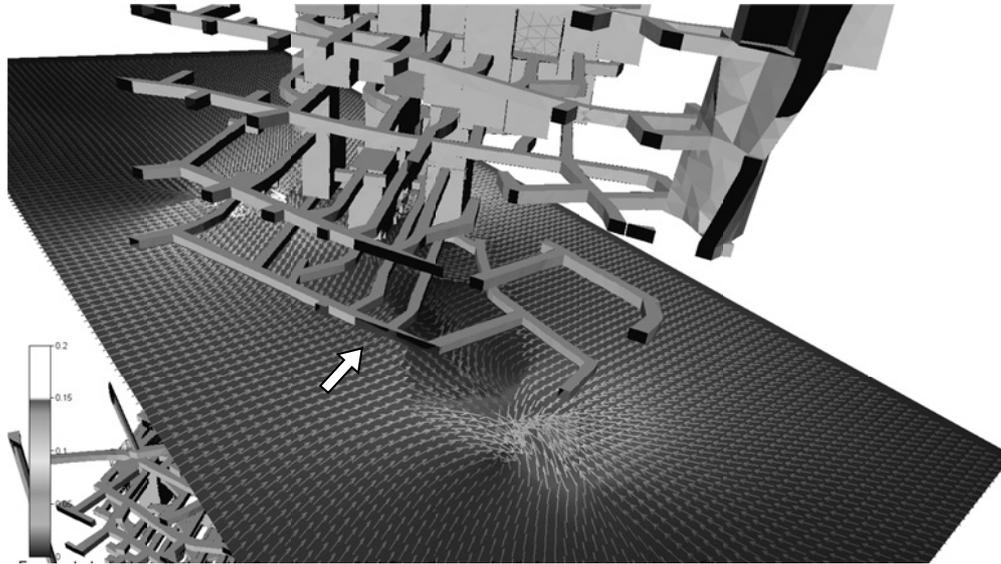
Figure 8 Forensic 3D strain softening dilatant explicit finite element model of the 2009 M_N 3.8 rockburst. The slip surfaces (primary and subordinate) are defined by the major change in vector orientation, and magnitude in the centre of the image. Local effect of unclamping in the foot wall caused by the mining of a stope in the satellite lens (hidden from view in foreground, but located at point of high vector concentration in centre of figure) was likely a trigger to the coalescence of the slip surface. Movement of the main foot wall north of the primary slip surface (left) is oriented east–west, into the main ore zone mining void. Figures 4 and 15(a) are of the nose of the pillar at the point of intersection with the slip surface in Figure 8, at arrow

After both events, several consulting firms were contacted to run numerical models or to update existing models to try and determine the underlying factors responsible for the events, and to better understand the ability of the system to reload in such a short time period, with essentially very little production extraction between events. Both distinct element and Abaqus-based finite element models were created, and the underlying mechanism was determined. After the event of 13 September 2011, the mining of the satellite lens was put on hold, and a total of 12 different mining sequences were tested using the models to determine if the risk of damaging seismicity could be reduced by modulating the rate of overall deformation and hence energy release. The initial model runs of unique sequences were used to determine the overall effectiveness of the proposed change, based on smoothing the energy release rate over time. Sequences which showed no benefit, or an increase in energy release rate per tonne mined in the short term, were discounted early in the process. Model sequences which showed promise were then investigated in further detail, including multiple variants in the timing of certain mining blocks to determine

overall strategy. As a result of this extensive work, it was determined that mining the satellite lens too early, while there was still significant stored strain energy in the main ore zone foot wall, was a potential trigger to the sudden slip of the foot wall on nascent structures (poorly defined joint sets), into the main ore extraction zone. By leaving the satellite lens until very late in mine life, the available energy which could be released in the form of damaging seismicity is anticipated to be reduced due to the ongoing deformation of the foot wall into the mined out main ore zone. As part of the refinement process of the most likely options, select panels were left as temporary or semi-permanent yielding pillars, to further limit the local rate and magnitude of foot wall deformation.

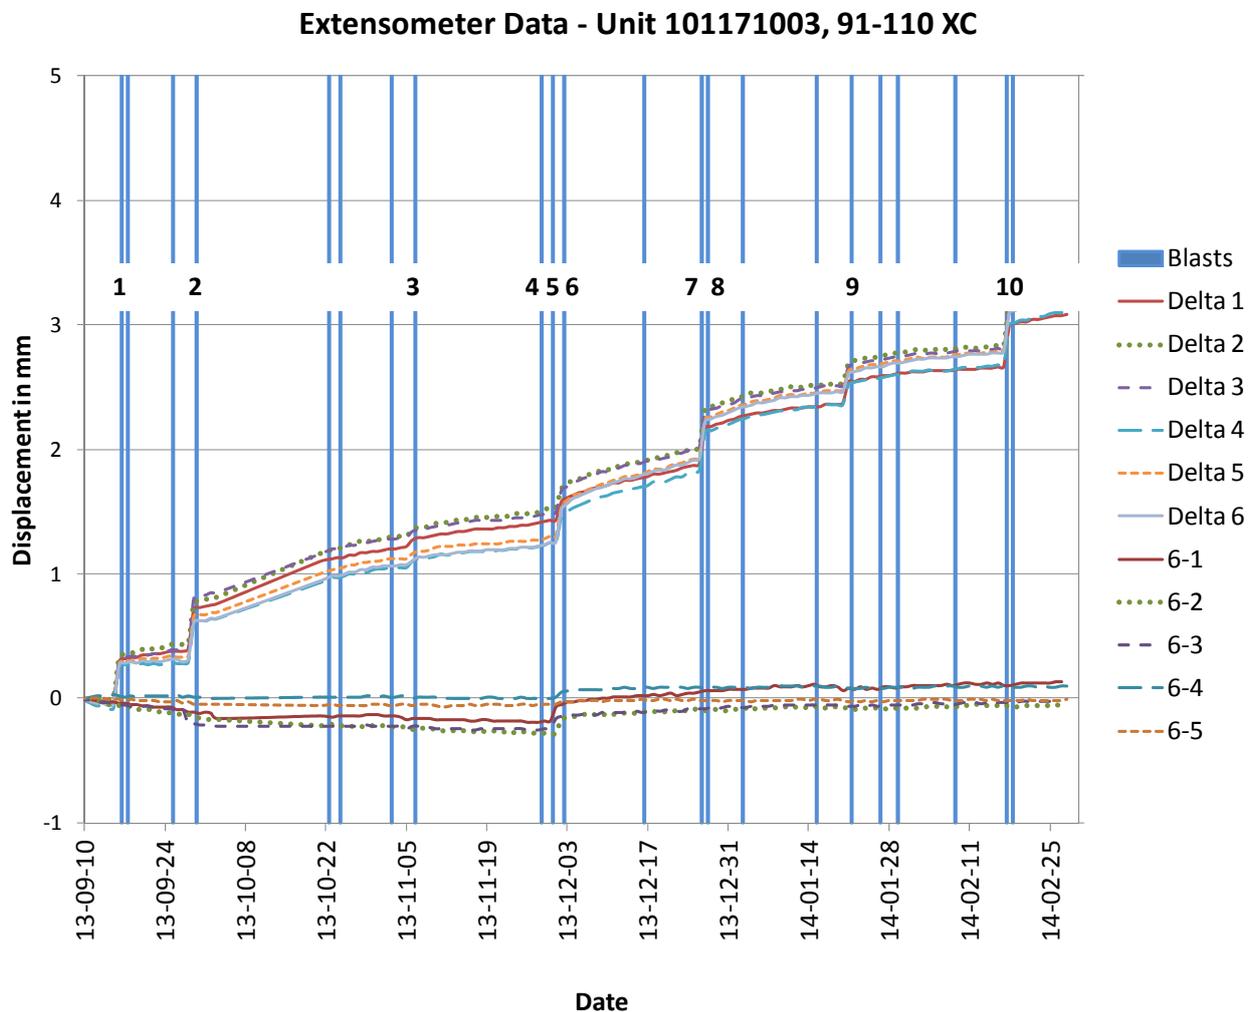
Figure 9 Extensometer readings, 91-110 XC. Note change in relative slip between anchors following $M_N 1.0$ seismic event of 29 November 2013. Note high correlation of deformation to production blasts, up to three levels away vertically, and 120 m distant laterally from the instrument. No apparent response from more distant production blasts (not flagged). Anchors at 1.67, 3.33, 5, 6.67, 8.33 and 10 m from collar

Instrumentation installed to monitor the effectiveness of different ground support tendons in the deeper portion of the mine has revealed other deformation linked to the mining of stopes up to several hundred metres away. Four extensometers, each 15 m long, were installed sub-horizontally in the walls of a drift in the ore, in the northern abutment on the 9100 Level. Two extensometers were installed in each wall, on opposite sides of the drift, approximately 10 m apart, immediately beside support tendons. The extensometers initially showed slight convergence, due to the shrinkage of the high strength grout used to install them. As blasting of proximal stopes occurred, subtle movement has been revealed, occurring not only at the collar, but beyond the depth of the bolts, as the rock mass is deforming towards the mined

openings. All four instruments are showing similar response, however, those instruments installed in the south-eastern wall of the crosscut, closest to the active stopes and structure, are showing the highest response. Instruments located in the northwest wall of the crosscut are showing substantially less response, as the void of the crosscut is shielding or interrupting the global deformation of the rock mass towards the stopes. The correlation with blasting is clearly evident in Figure 9.

Those instruments which cross through known moderate structures which extend towards the active stopes are also showing signs of shear, as the intermediate anchors are moving more than the shallow anchors on occasion, and not all anchors are moving in the same sense. The most significant movement has been occurring between anchors 2 and 4, which are between 3.3 and 6.7 m beyond the collar. Significant movement was also noted following a strong ground motion (SGM) $M_N 1.0$ seismic event, on 29 November 2013.

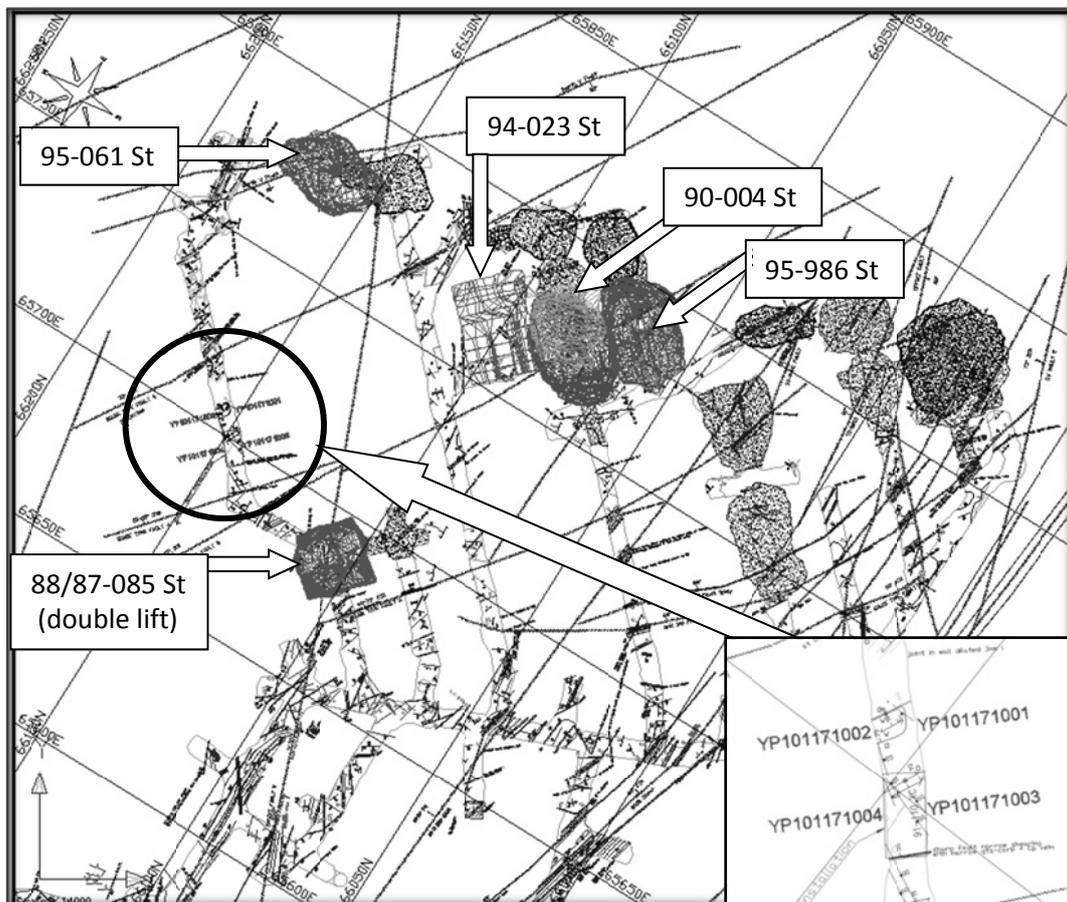
Figure 10 Location of extensometer array in 91-110 XC. Stopes influencing displacement projected to 9100 Level plan. Stope survey shown where available, otherwise blast design volume. Stopes showing most influence all lie to southeast of instruments, down strike on structure. 95-986 St filled prior to blasting 94-023 St

Table 1 Blast dates for stopes influencing instrumentation in Figures 9 and 10

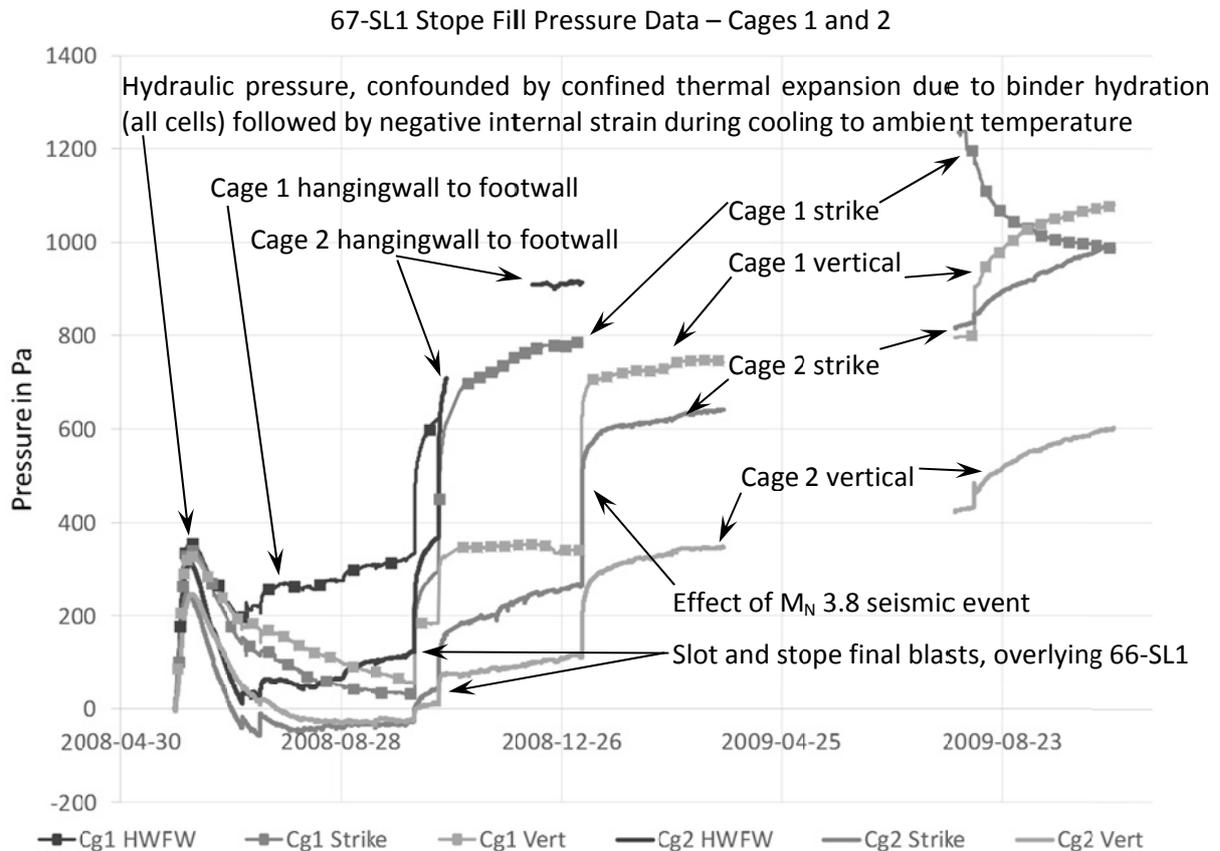
Figure 11 Total Earth Pressure cell data, 67-SL1 Stope. Cells measure stresses orthogonally normal to the hanging wall, parallel to strike, and vertically. Traces from the three cells in Cage 1 are shown with data markers for clarity. Cage 1 located just within hanging wall of stope; Cage 2 located just inside brow. Block above the instrumented stope was blasted 7 and 20 October 2008, resulting in abrupt change in all cells. Cells measuring hanging wall-foot wall failed during the final blast in 66-SL1 St. M_N 3.8 burst 6 January 2009 resulted in abrupt change in stress. Missing data from March to August 2009 due to temporary removal of the data logger to allow development of adjacent stope

An unexpected but fortuitous outcome of the extensive instrumentation program associated with the University of Toronto was that a limited number of the low range (500 kPa) total earth pressure sensors installed to monitor the short term behaviour of the paste were still functioning at the time of the significant seismic event in January 2009. The excitation circuit for the vibrating wire readout was changed midway through the monitoring process to try to extend the life of the cells, however most failed at pressures approaching 1 MPa. In those cells which remained functional 6 months after installation, the strain induced by the M_N 3.8 burst resulted in changes in the induced stresses measured within the paste

fill which were of similar or larger magnitude to those which occurred due to the closure associated with the removal of the overlying stope.

As shown in Figure 11, after the cessation of the thermal effects of paste curing, (Thompson et al. 2014) the cells oriented parallel to the hanging wall and foot wall showed the most change as the stope immediately above the instrumented fill was mined, causing closure. Those cells failed on overpressure early in the monitoring programme. During the M_N 3.8 seismic event, of the remaining active stress cells, those measuring the change in stress sub-parallel to the strike direction of the slip surface showed the most change. This is to be expected as the slip vector associated with the M_N 3.8 event was confirmed through surveying of original drift stations to be oriented sub-parallel to the break plane (dextral strike slip), hence compression of the fill due to the deformation associated with the event would have the most influence on these cells. Changes in stress could also be observed in a second instrumented stope located over 500 m below the epicentre, in the south abutment on the 8800 Level. Further work is to be undertaken to instrument other stopes with a limited number of much higher range total earth pressure cells (currently specified at 7.5 MPa nominal capacity), in order to extend the monitoring period available prior to cell failure, and to determine if changes in the deformation of the fill can be used as a reliable analogue for deformation of the surrounding host rock, as an aid to calibration of the stress models.

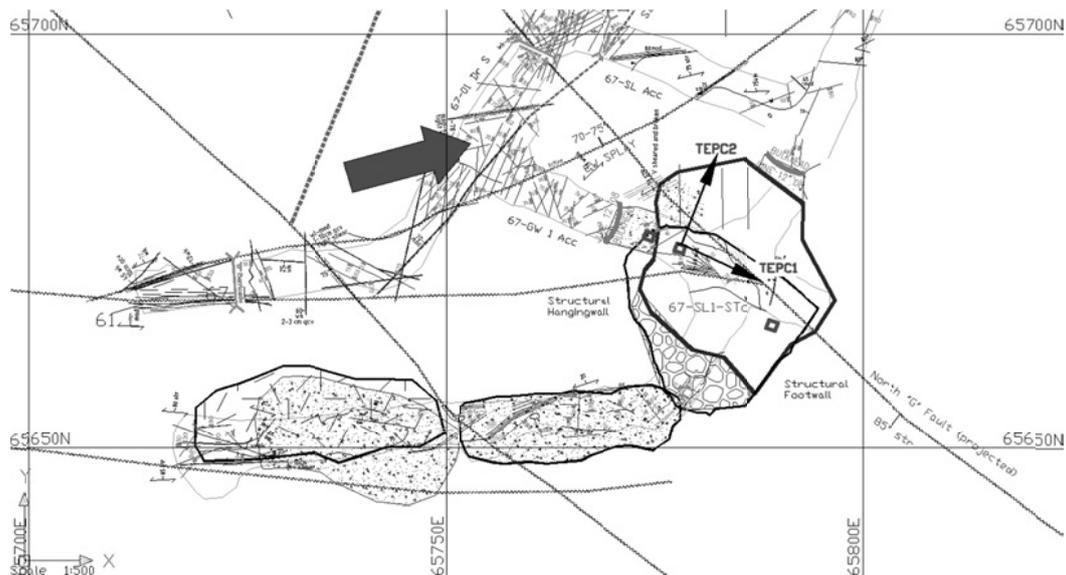
Figure 12 Plan view of 67-SL1 Stope showing location and orientation of instruments 1 and 2 in each cage (TEPC3 measures vertical load). Cage 1 is closest to the stope hanging wall, and Cage 2 was located in the access drift, under the brow. Cage 2 would be subject to less regional deformation, as it was essentially located within the rock mass, while Cage 1 was substantially surrounded by fill. Large arrow indicates approximate far field slip direction of foot wall during M_N 3.8 seismic event, 6 January 2009

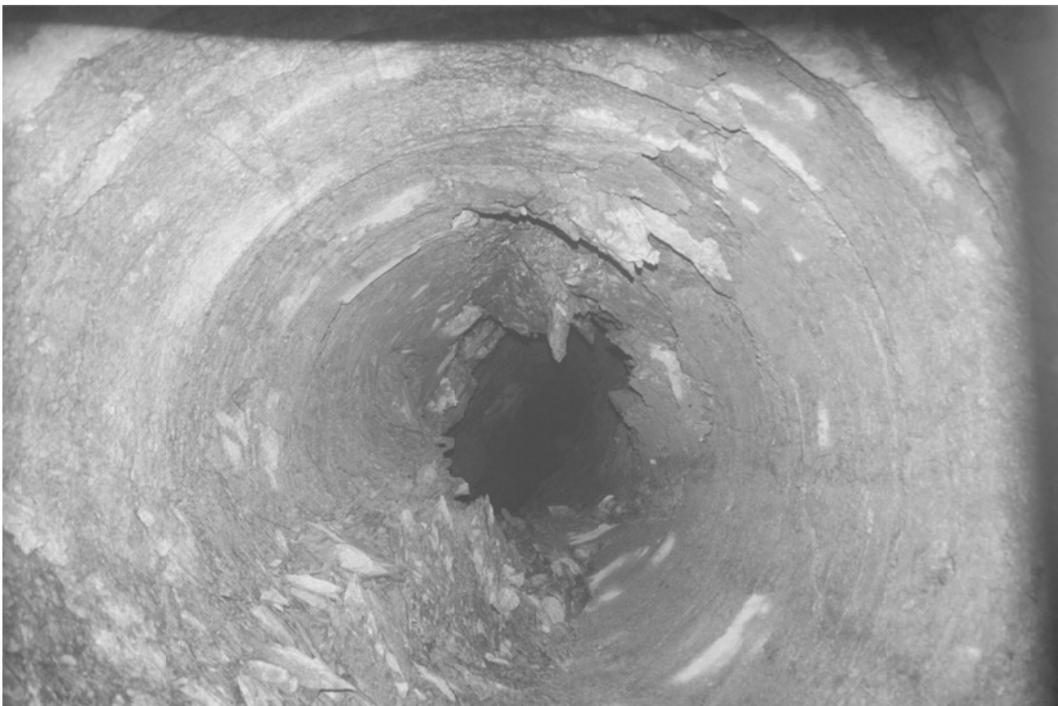
Figure 14 Early stages of breakout in reamed slot raise, 91-040 Stope

Due to the weak and strongly structured nature of the rock mass, and the high stresses at depth, other issues continue to cause challenges to the operations. Crushing and caving of production blastholes and slot raises due to the high rates of convergence, as shown in Figure 14, have resulted in several operating changes. Most recently, sacrificial raises have been bored several weeks to months in advance of the primary slot raise for stopes in the abutments, and in the hanging wall of primary panels at depth. The first raise is given time to yield, which effectively de-stresses and fails the ground, allowing the second raise to be drilled with less difficulty.

This also provides enough strain relief to reduce the crushing of the primary blastholes around the slot to tolerable levels, although as the ground is highly fractured, caving becomes a secondary concern. Where the ground is so failed that raises cannot be reliably excavated, stopes have been mined by drilling shallow rings of holes from well outside the stope boundary, and 'slapping down' the ore in sub horizontal slices into the open undercut below. Once the inclination of the holes is such that the break angles no longer allow blasting from the undercut elevation, similarly oriented holes are drilled from outside the stope boundary on the overcut, allowing the sub horizontal slicing to continue to the overcut. This same approach has been used in areas where access is not possible due to the high levels of damage incurred during the major bursting of the last five years.

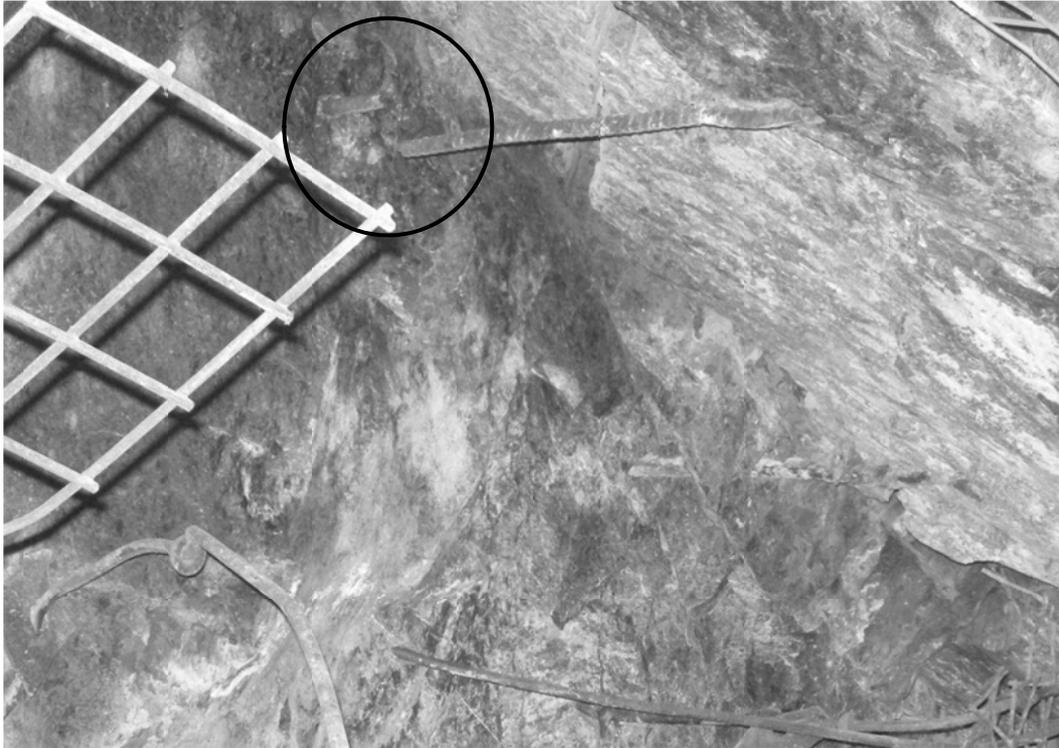
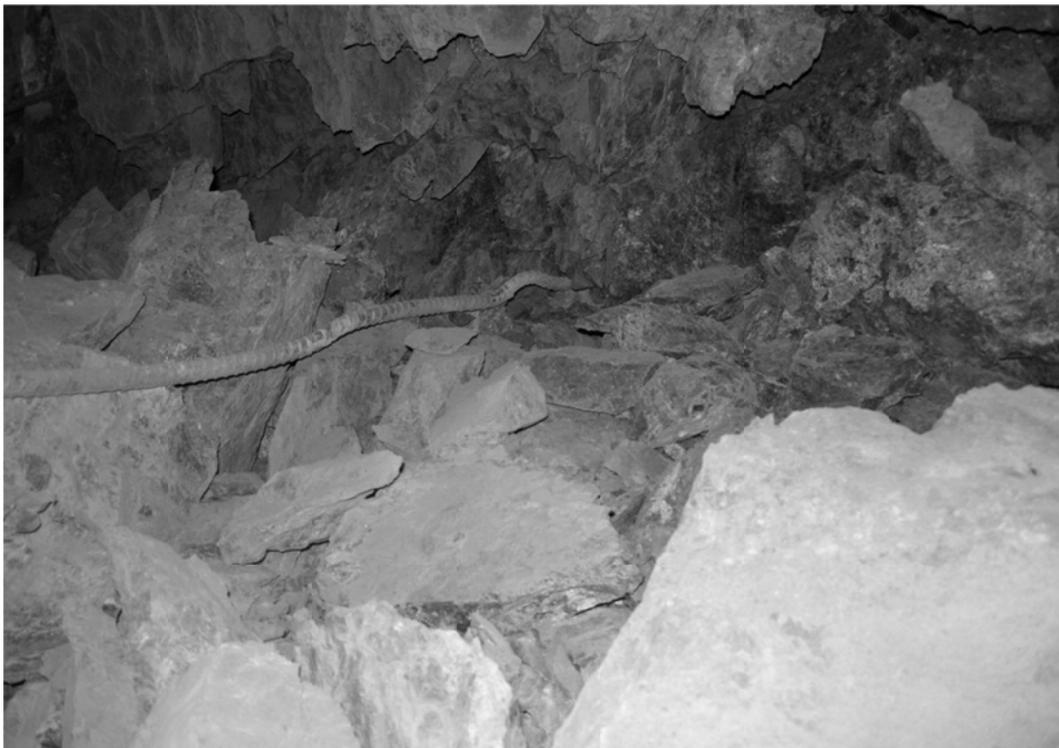
Figure 15 (a) sheared rebar through rupture trace, with minor undulations near intersection with rock surface and no damage apparent at plate, 70-82 XC entrance; and (b) undulation imparted in 22 mm rebar by transverse vibrations occurring within the rock mass prior to ejection, 70-82 XC, both following M_N 3.8 burst, 6 January 2009. This type of deformation resulted in the lock up and failure of adjacent MCB 33 cone bolts. Image (a) is of the same area shown in Figure 4, after the removal of the pulverised rock. The strong joint bounding the upper failure surface is visible in the centre right of Figure 4
