# Addressing the Risk of Major TSF Failures

## ABSTRACT

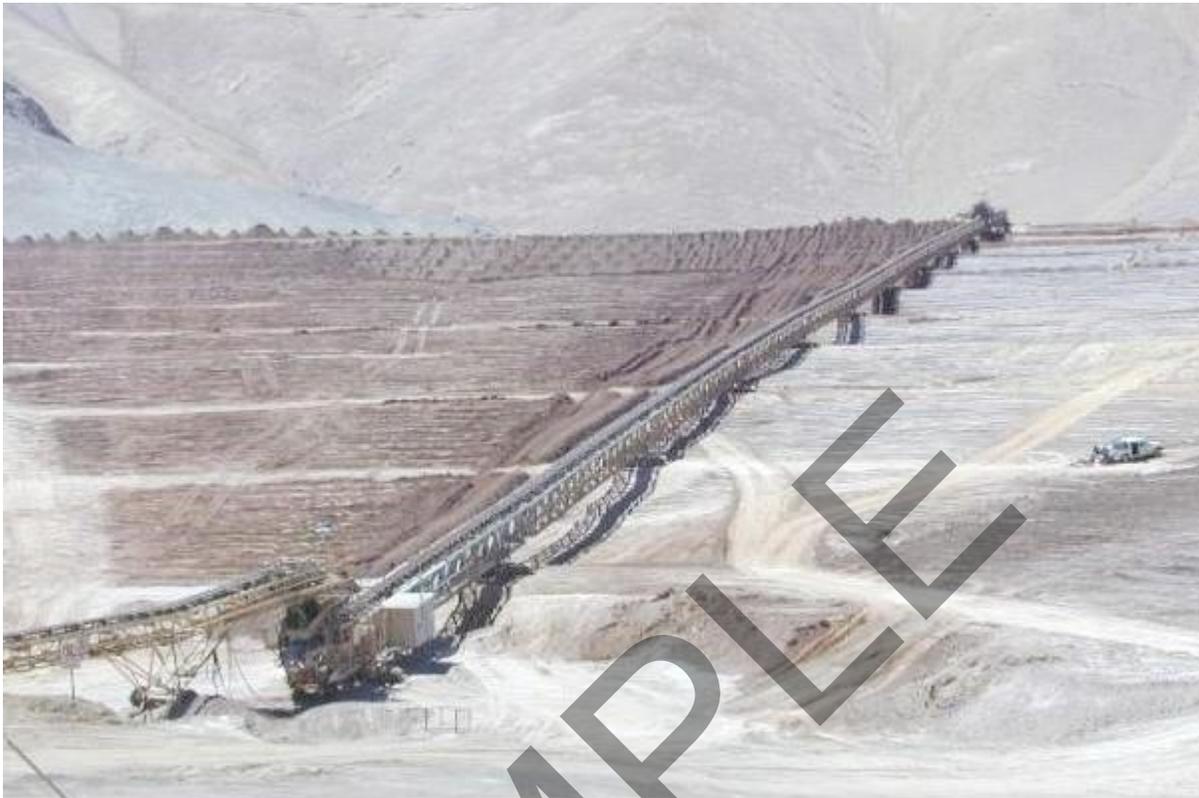
**Figure 1** Dry stacking at the Compañía Minera Mantos de Oro mine in Chile. The plant at this Placer Dome operation had a nominal capacity of 15,000 tpd

Filtering is the most expensive form of thickening and for above ground storages is mostly used where maximising water recovery is the driver. Filter cake contains no excess pore water and conventional earthmoving techniques are utilised for transporting and disposing the material in a very stable form often referred to as “dry stacking”. Filter cake would be very unlikely to be susceptible to liquefaction and there are operations at which filtered tailings have been stacked and stored to considerable depths without any confining embankment. This would eliminate the problem of embankment stability and liquefaction of stored tailings but would not be practicable at all sites. Furthermore, the cost of setting up and operating the facility would be considerable and could most likely not be justified except under extreme conditions. However, to illustrate the concept, Figure 1 below has been taken from a case study presented to the ACG Paste 2001 seminar in Santiago by Luis Pizarro, the Plant Superintendent on the Manto de Oro gold mine in Chile.
